Inspection Report
Minerals Regulatory Program
September 1, 2009

Mine Name: Pitchforth Springs/Multicolor Green	Permit Number: S/027/0033
Operator Name: Dale D. Rogers	Inspection Date: 06/30/2009
Inspector(s): Brett Gregory for Tom Munson	Time: 2:00 pm
Other Participants: None	Mine Status: Active

Purpose of Inspection: Routine inspection to photograph and document the site conditions.

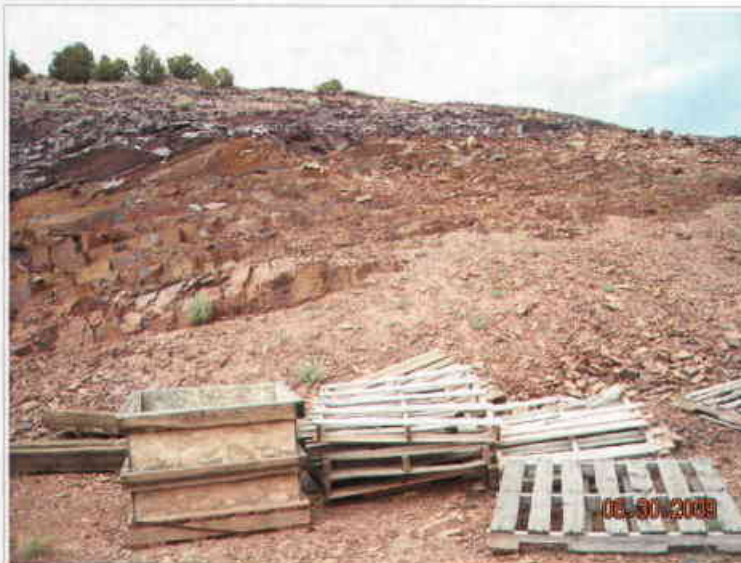
- 1) The bond is due for escalation this year. All permit fees have been paid in full.
 - 2) There were several wooden pallets found on site. They need to be removed if not being used.
 - 5) There is some question whether the road disturbance made to the northeast is on BLM or SITLA property?
 - 10) Some of the plants growing within the disturbed area are noted below in the photographs.
- (Photos attached)

Unused pallets.

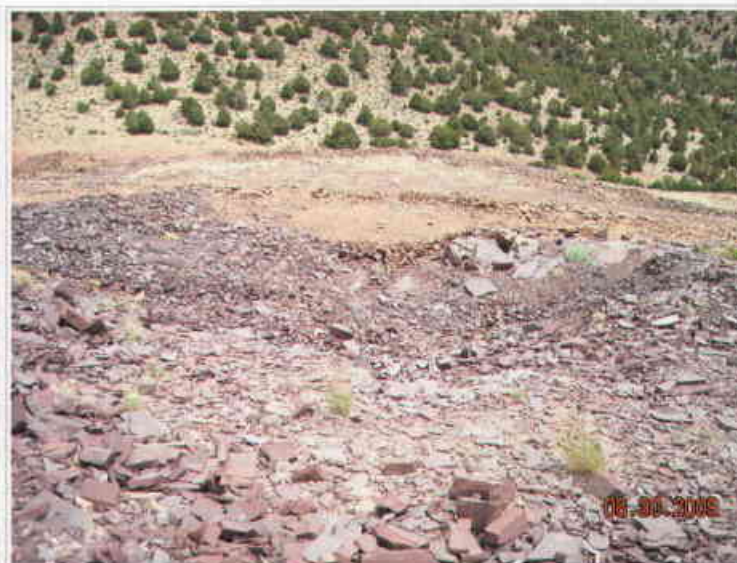
Main body of disturbance.

The GPS map from my inspection indicates the mine is over five acres of disturbance (~7.10 acres). This puts the operator in a position to choose one of the following alternatives:

- 1.) The operator may reclaim the quarry leaving the current \$6,800 in place to guarantee revegetation success.

- 2.) The operator may submit a Notice of Intention to commence a Large Mining Operation and post an interim bond totaling \$33,200.
- 3.) The operator may reclaim to a small mine status of 5 acres or less, post additional bond (\$17,800 for a total of \$24,600) to bring the bond to current bonding cost estimates for a five acre disturbance.

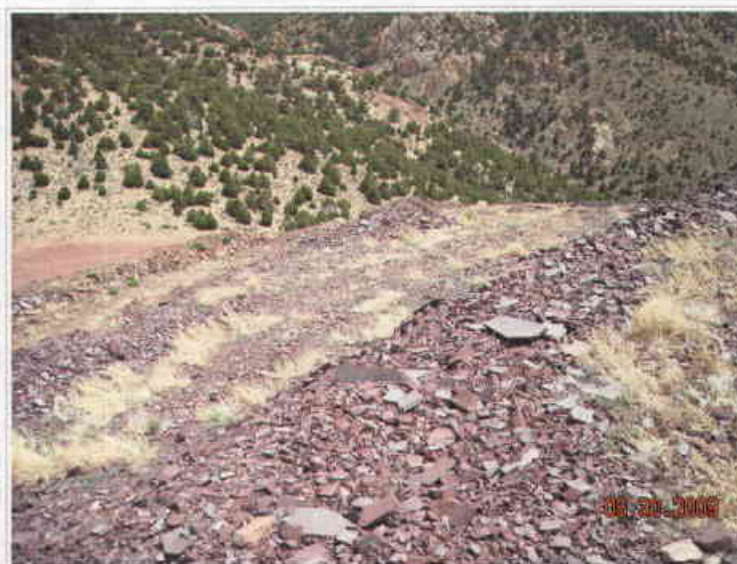
Vegetation growth indicates no recent mining activity.

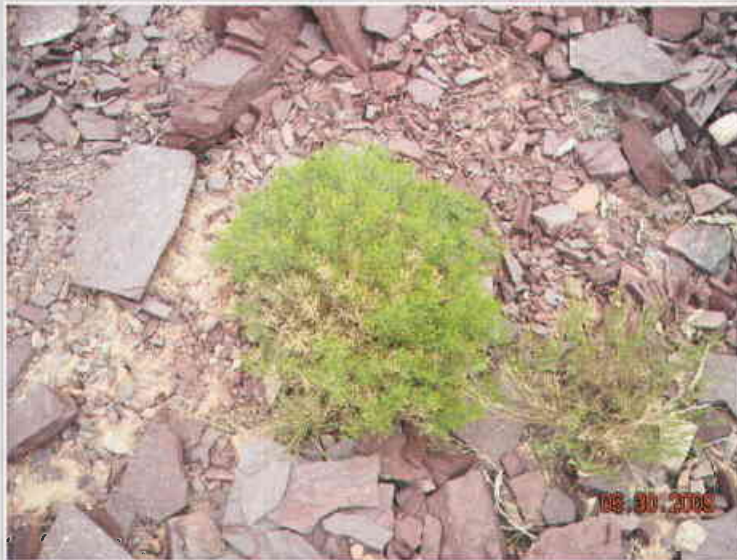
Snakeweed.

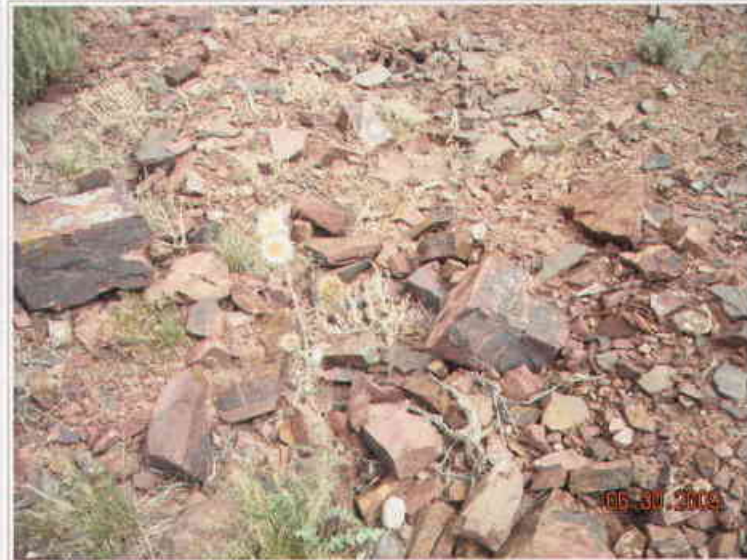
Native thistle.

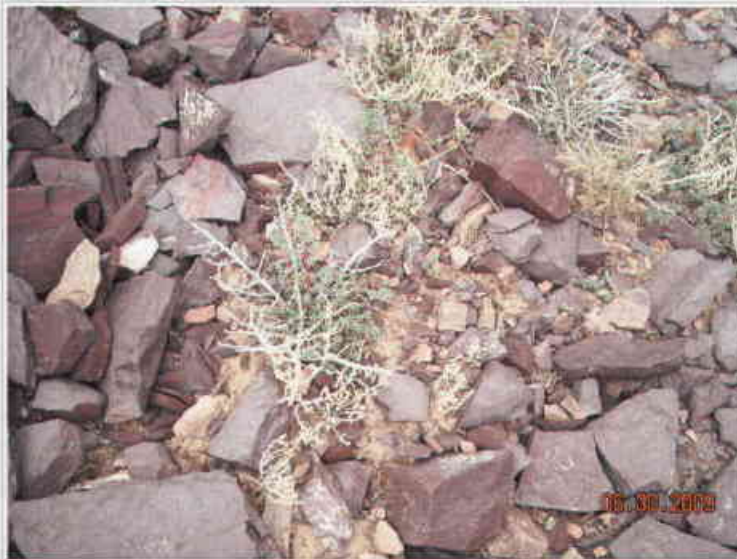
Halogeton.

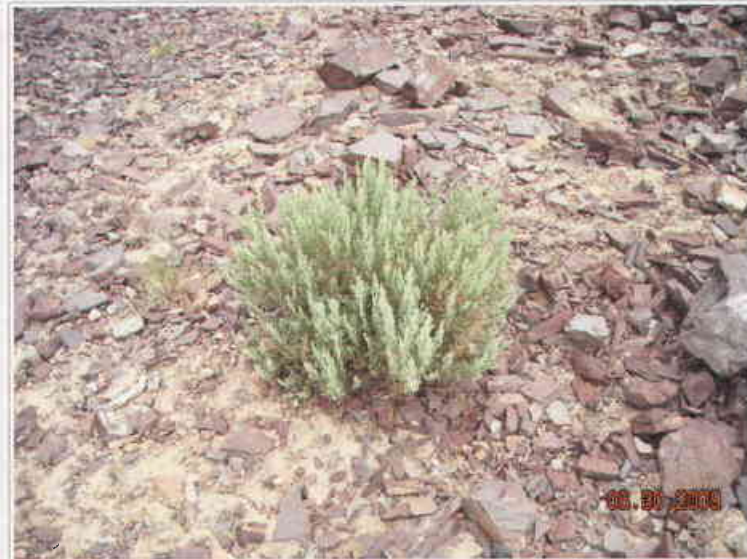
Sagebrush
